IB-SK		
Musterort		
Sanierungsplanung		
VG Musterhausen		
3.01	27.07.2007	M.: 1:500

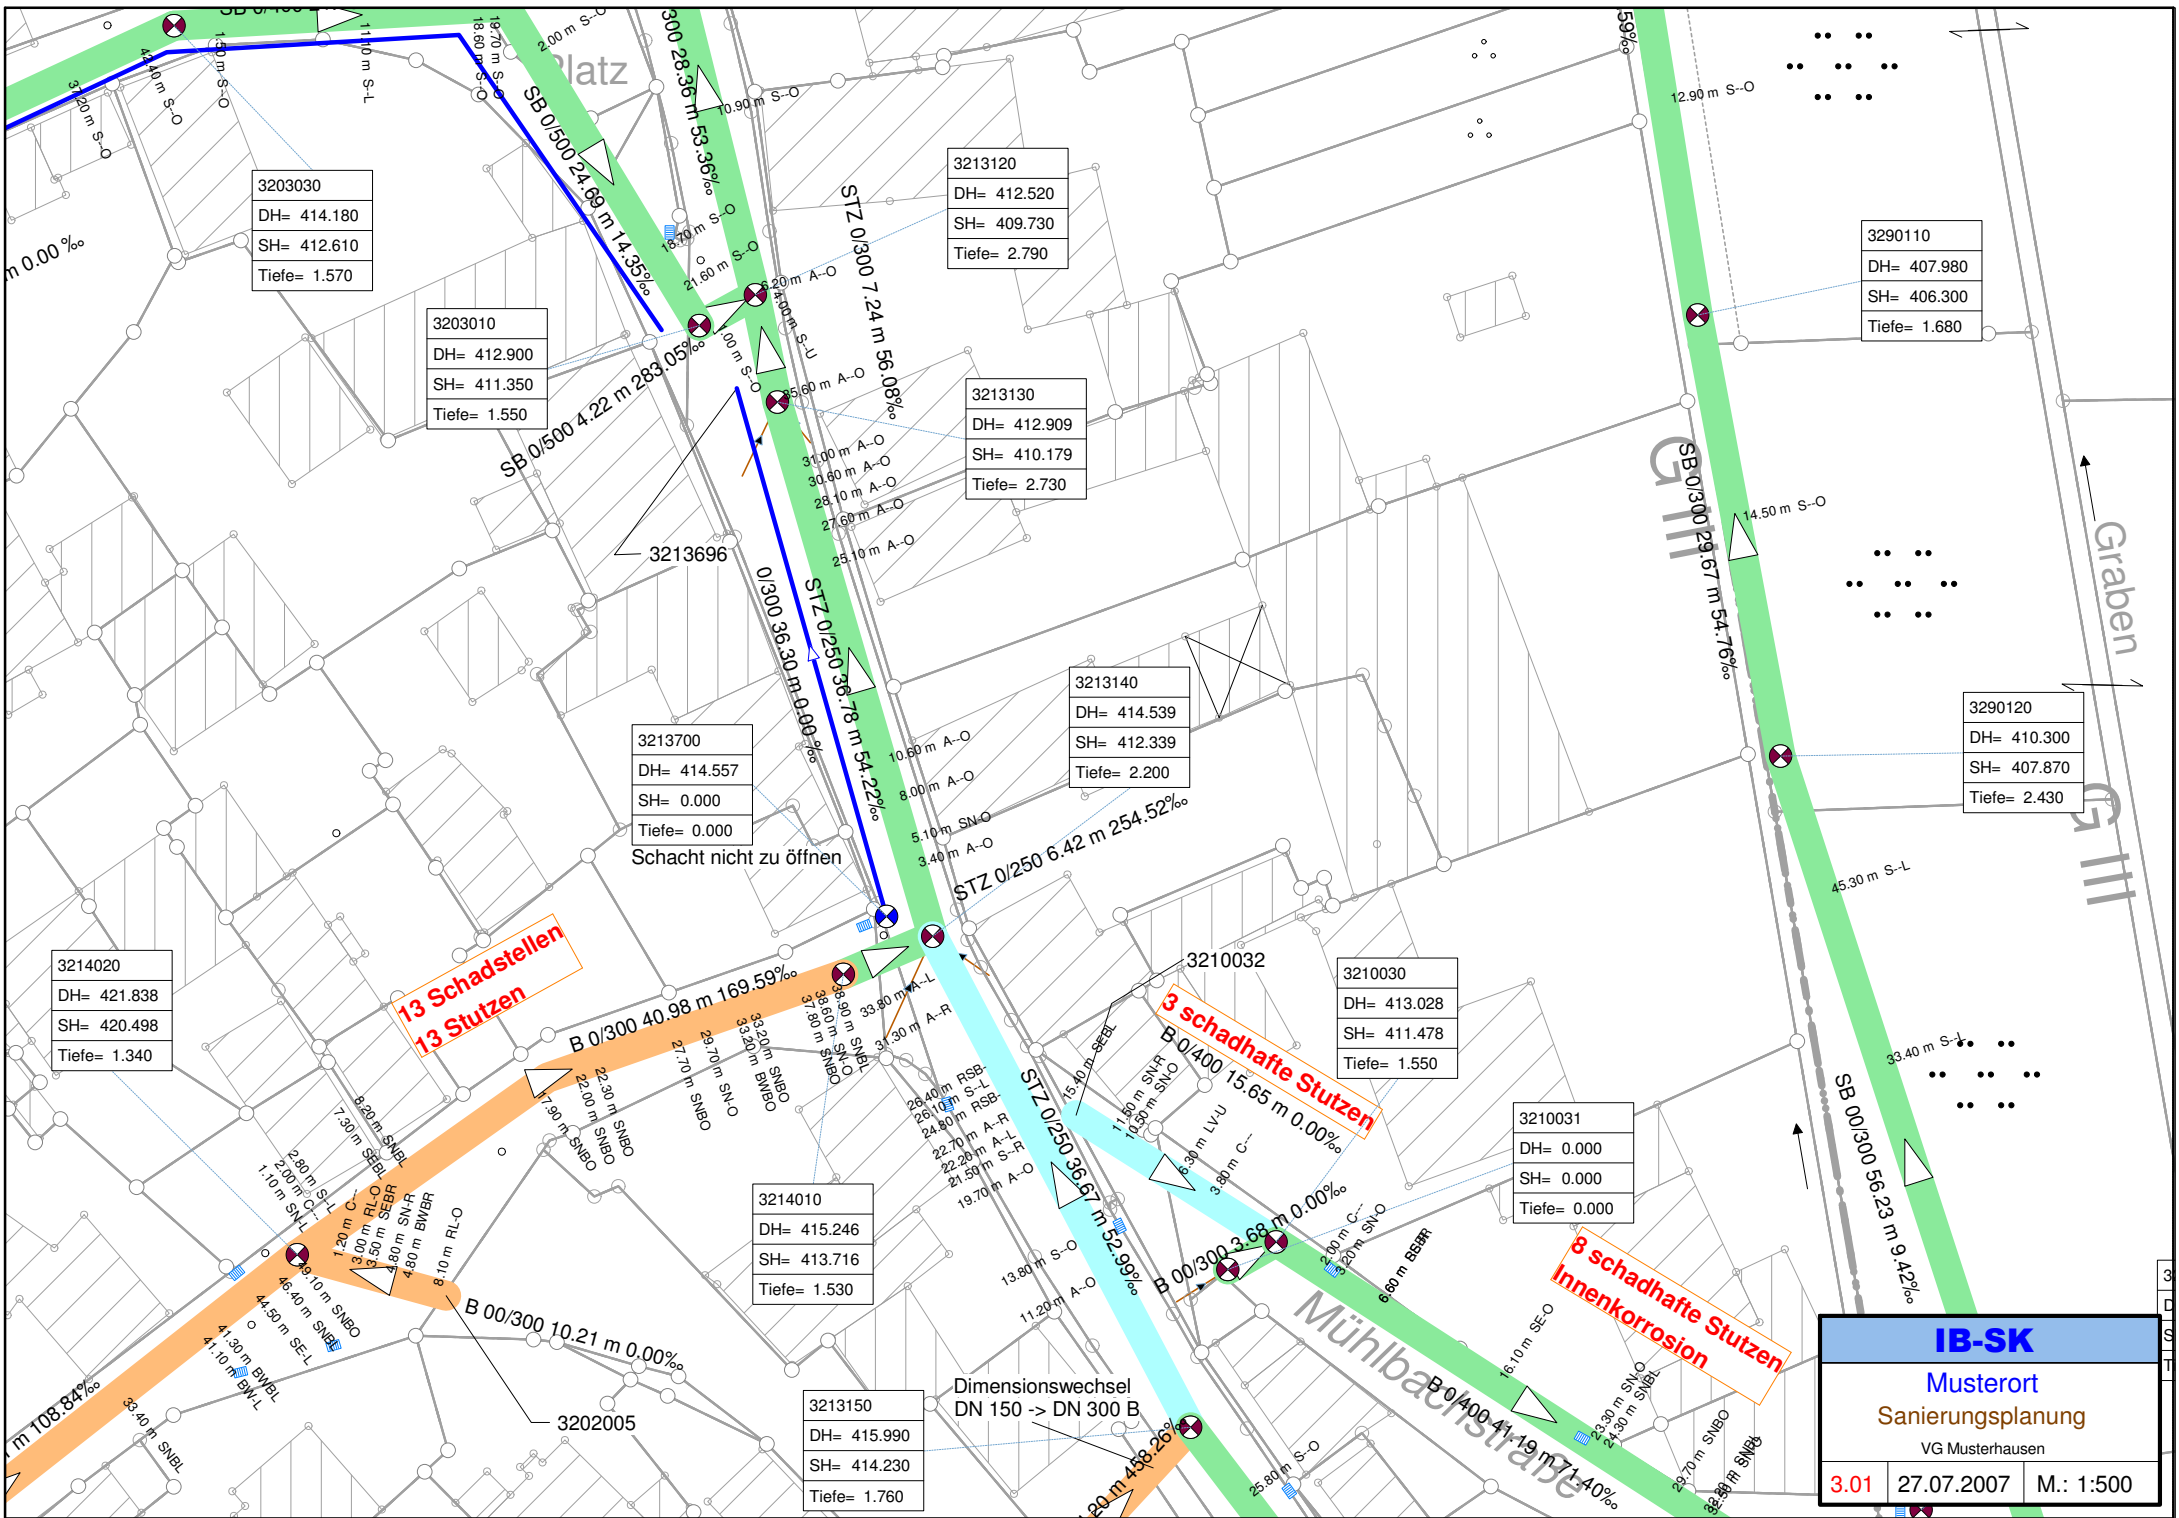
3213700
DH= 414.557
SH= 0.000
Tiefe= 0.000
Schacht nicht zu öffnen

**13 Schadstellen
13 Stutzen**

3 schadhafte Stutzen

**8 schadhafte Stutzen
Innenkorrosion**

Dimensionswechsel
DN 150 -> DN 300 B
